Maintenance News

18
Spring
1981

Editorial	1
The Woodley and Broughton strikes	1
Isolation : cable	2
Datel's new modem 27A	3
Planned work	5
Second harmonic testing of coaxial cables	6
Wiper-to-bank noise in Strowger exchanges	9
Modernising telex	10
A strategy for improving the repair service	12
LTR makes the MOST of its RT13s	14
Don't plan a service interruption	16
London's sector switching centres – SSCs	17
Optical fibre line systems' maintenance	20
Channel Islands restoration plans	22
New equipment practice – TEP1E	23
Digital transmission – the basic PCM system	24
Maintenance thoughts on new coin boxes	27
Computer aid to exchange maintenance	28

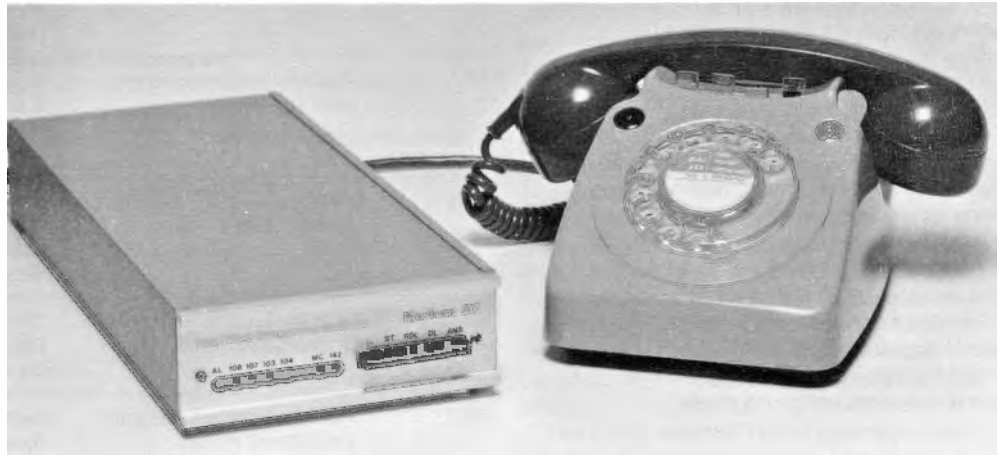
Modem 27A and associated telephone

Basically, Modem 27A is a synchronous type but also contains a synchronous-to-asynchronous converter. This means that although the data between modems is

always isochronous, the modem can be installed to provide one of three discrete data formats between the customers' data terminals. The optional data formats are set by switches and only similarly optioned modems can interwork.

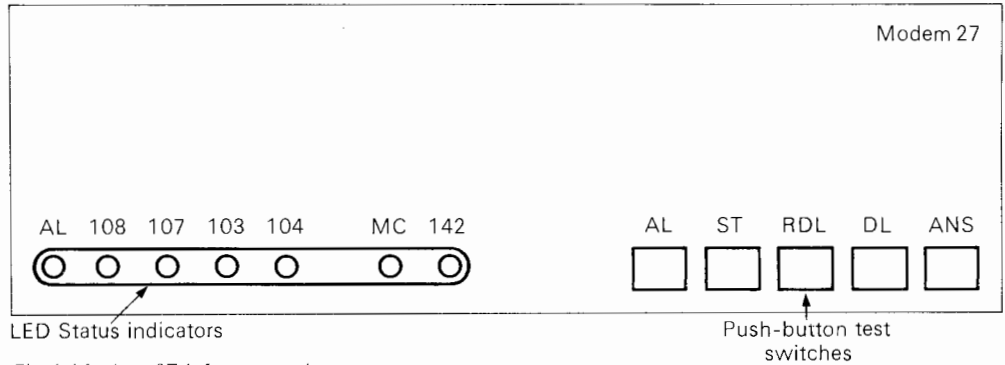
Fig 1 Modem 27A front panel

Table 1 Switches

Marking	Function	Remarks
AL	Puts the local modem into Analogue Loop mode	This loops the transmit to receive at the line side of the modem. The modem uses an internal frequency-changing process to take account of CALL and ANS channels.
ST	Puts the local modem into Self-Test mode.	An internally generated test pattern (1 :1 reversals) is scrambled and transmitted to line. Received data is monitored, compared with the internal test pattern and MC indicator flashed for received errors.
RDL	Puts the remote modem into Digital Loop mode.	A handshake procedure conditions the remote modem to apply a Digital Loop (effectively a loop between interchange circuits 103 Transmitted Data and 104 Received Data).
DL	Puts the local modem into Digital Loop mode.	On modems set for asynchronous working the Digital Loop (Local and Remote) DOES NOT include the synchronous to asynchronous converter.
ANS	Puts the local modem into the Answer mode.	Selects the 2400 Hz carrier and 1200 Hz receive filter.

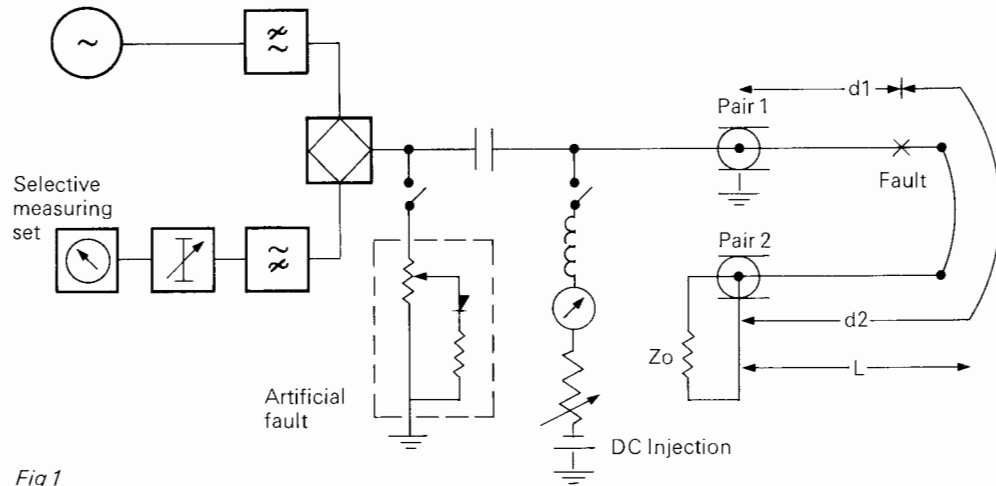
HR joints can be located by the second harmonic test – Fig 1 – which uses the non-linear characteristics of the defects to produce harmonics, the second harmonic being the larger. The output of a variable oscillator is connected through a low-pass filter to the transmit terminals of a hybrid termination. The signal at the receive terminals of the hybrid is connected to a high-pass filter and then to a selective measuring set, tuned to twice the frequency of the sending oscillator. The 'transmit' filter passes only the fundamental frequency of the oscillator, whereas the 'receive' filter passes

Variable frequency oscillator
100-150 kHz

only the second harmonic generated by the HR fault ; other unwanted frequencies are suppressed. The faulty coaxial pair is connected to the 'line' side of the hybrid and is correctly terminated at the far end to prevent signal reflections. An artificial fault – a small diode and variable resistance – is also connected in parallel with the cable to the 'line' terminal of the hybrid. Second harmonics are produced in both the real and the artificial faults. By varying the frequency of the sending oscillator, the second harmonic produced goes in and out of phase. This effect registers as peaks and troughs on the level measuring set. The frequency at

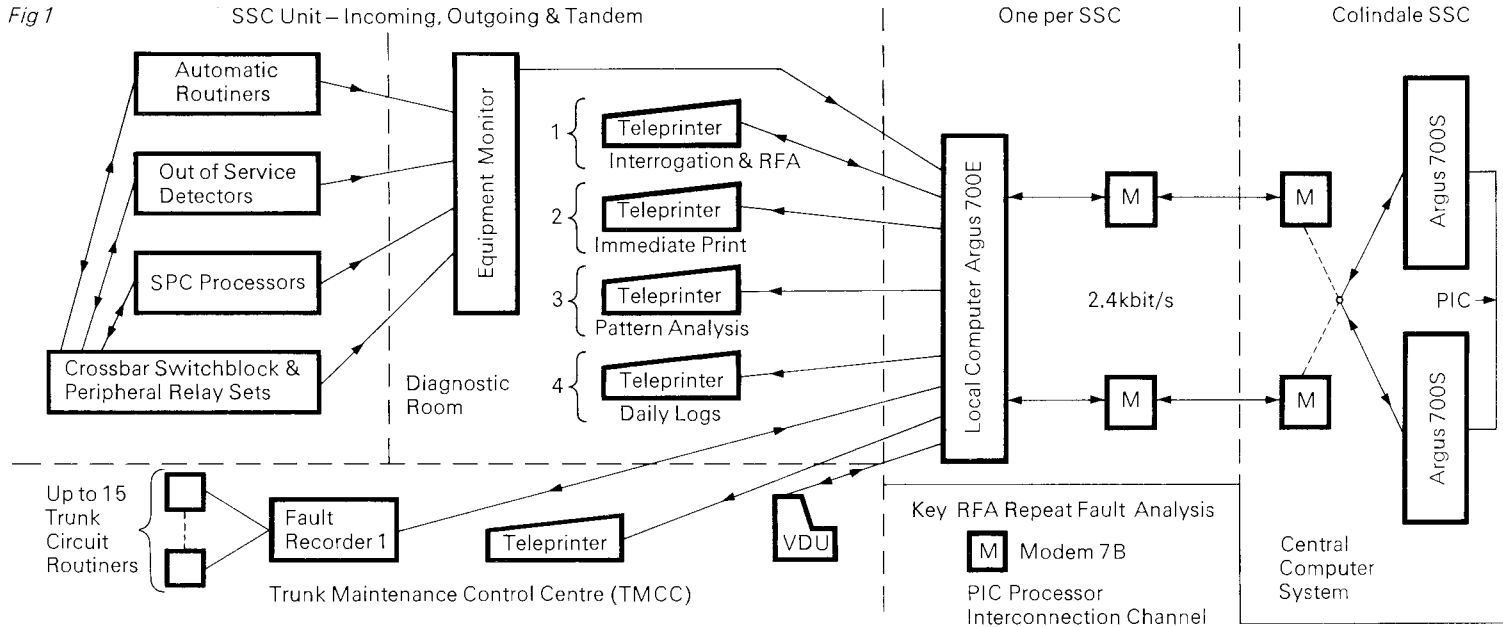
Fig 1 shows the basic computer system interface with the exchange maintenance

equipment. Input from the exchange equipment is taken in the form of reports from the equipment monitors, fault recorders and, using manual entry, from interrogation teleprinters or the VDU.

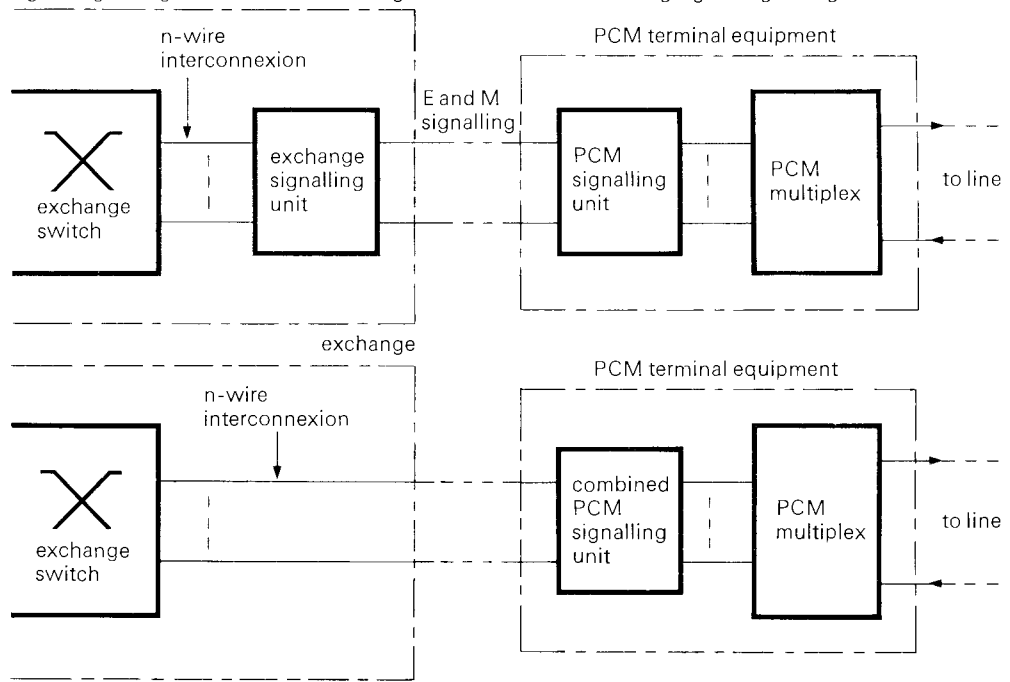
Fig 3 Simplification of signalling arrangements

PCM equipment in association with normal existing signalling arrangements
